Operating Experience Weekly Summary 97-08

February 14 through February 20, 1997

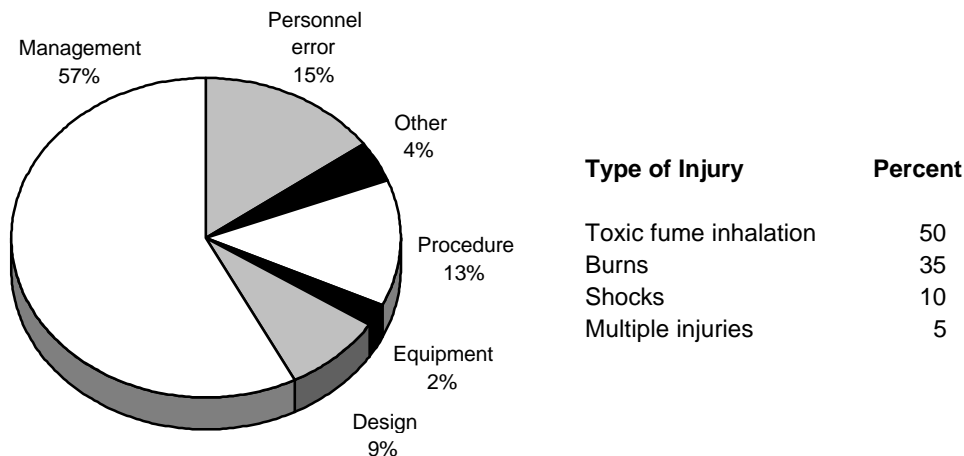
OEAF engineers reviewed the Occurrence Reporting and Processing System (ORPS) database for all reports involving welding and cutting operations that resulted in injury or fires. Figure 2-1 shows facility managers reported management problems as the root cause for 57 percent of these events. Seventy percent of the management problems were the result of work organization/planning deficiencies or policies not adequately defined, disseminated, or enforced. Facility managers reported that 21 injuries resulted from these events. Figure 2-1 includes a breakdown of the types of injuries caused by torches or welding.

Figure 2-1. Distribution of Root Causes for Welding and Cutting Accidents with Breakdown by Types of Injuries¹

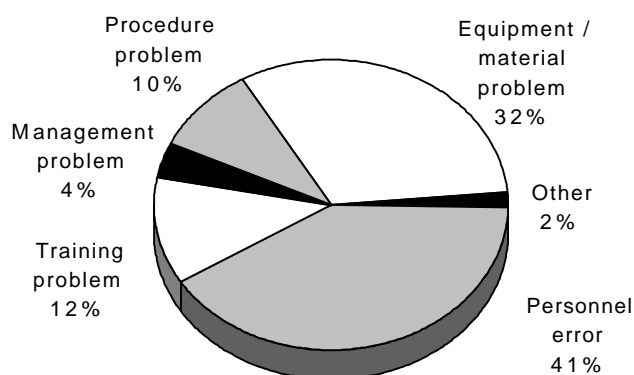
OEAF engineers reviewed the Occurrence Reporting and Processing System (ORPS) database for electrical shocks or near-misses and found 235 events across the DOE complex. Personal error was the direct cause of 41 percent of these concerns. The high percentage of personnel errors reinforces the value of additional barriers to supplement human performance. Figure 3-1 depicts the distribution of the direct causes.

Figure 3-1. Direct Cause of Personal Safety Concerns Involving Electric Shocks¹
